November 30, 2010

**Subject: November 23, 2010 Site Inspection; 4th and Gambell Site; Anchorage, Alaska;
NTP 18-4002-11-007B**

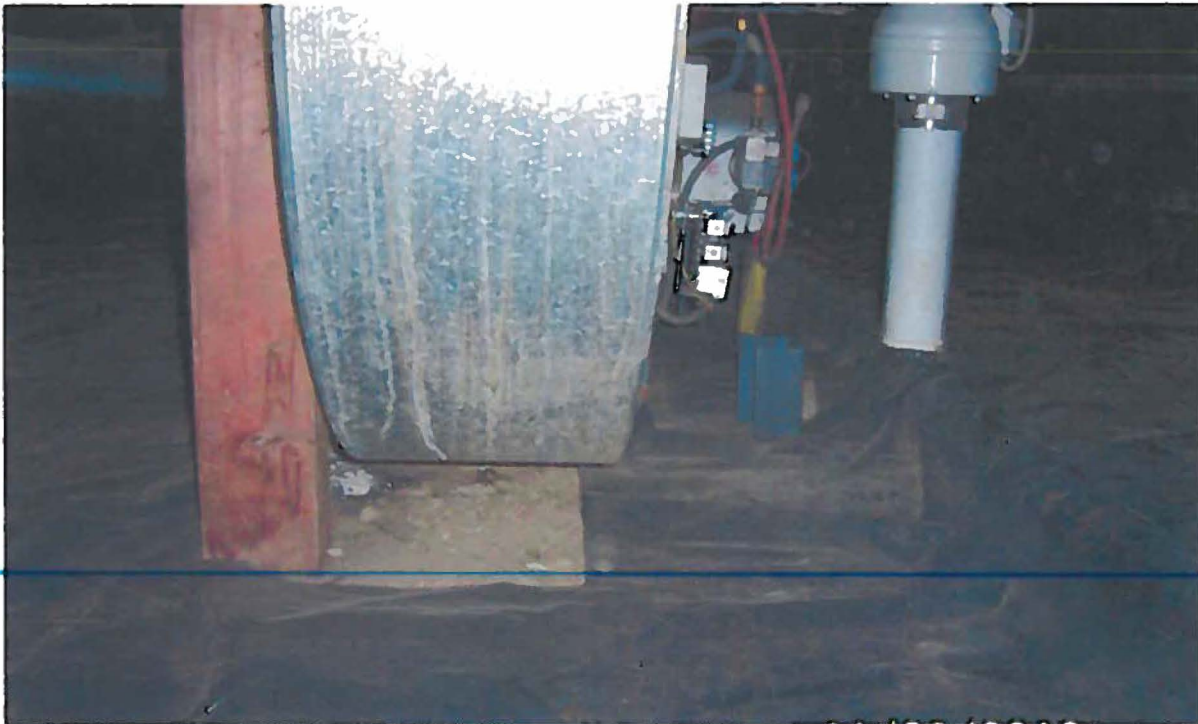
- North Duplex – Photographs 1 through 4 in Attachment 2 show that there are several penetrations through the membrane liner used to seal the crawl space. These penetrations prevent a complete seal of the soil gas contained beneath the building and even though the SMD air pump is operating it is unable to capture all of the subsurface soil gas contamination that is being pulled into the crawl space. Due to furnace operations and house stack effects that occur during cold atmospheric conditions we would expect the crawl space concentrations to be greatest during the winter months. The house stack effect is illustrated and described in Attachment 2 Picture #8.

Photograph 1: North Duplex submembrane depressurization system (SMD). Notice hole in membrane liner below furnace and next to wooden support pier.

OASIS recommends that the membrane liner penetrations and joints at the North Duplex be repaired and sealed. Once completed a vacuum test of the system can be done to determine if the SMD is generating sufficient vacuum to withdraw vapors from below the liner. A new set of vapor intrusion samples can then be collected to confirm that the SMD systems are being effective in reducing the crawl space contaminant concentrations. Both of these SMD systems are discharging directly outside the building near the ground surface, to prevent potential exposure to the discharged air it is also recommended that the vent pipes be extended up the side of the structure to a location above the roof line.

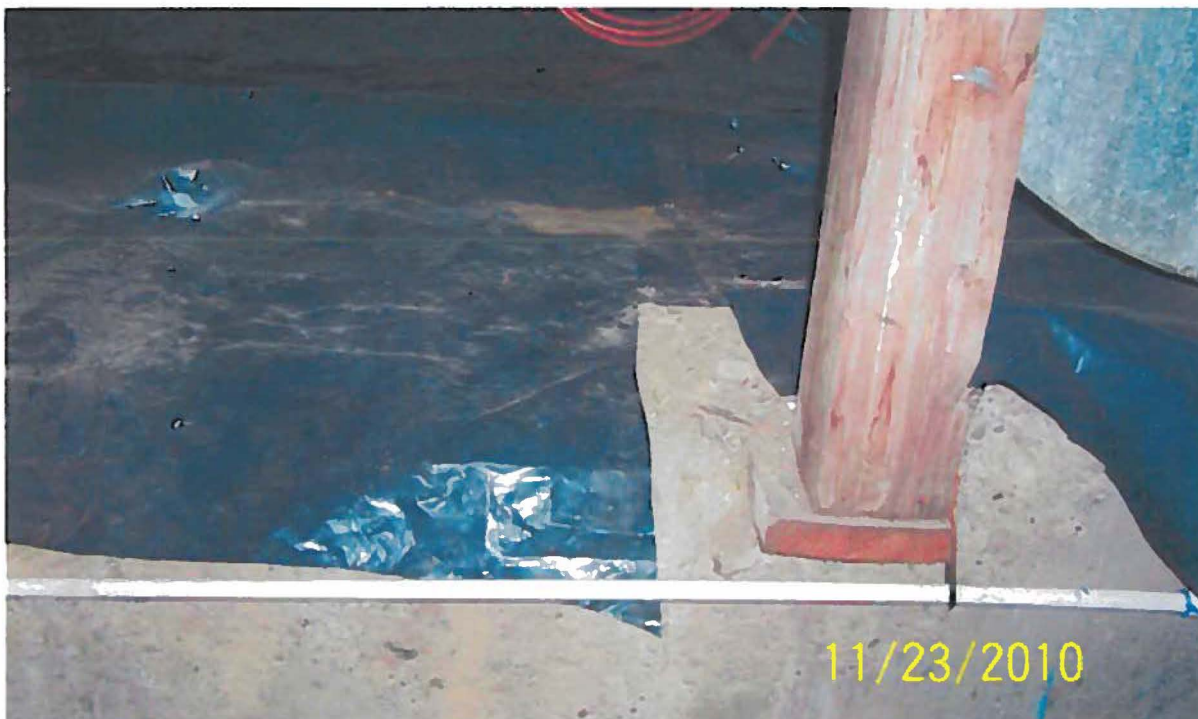
Photograph 2: North Duplex membrane liner not sealed to concrete slab and penetrations adjacent to wooden support pier

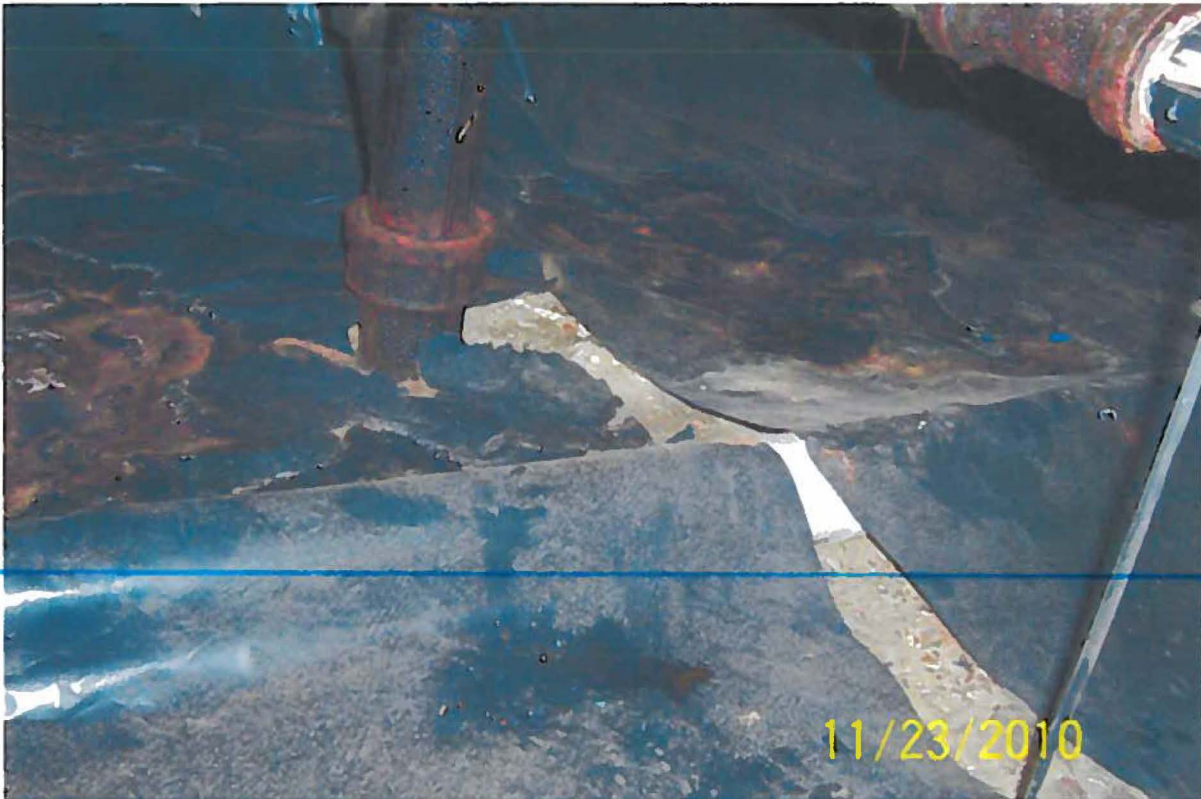
Photograph 3: North Duplex – Another photo showing penetrations through membrane liner adjacent to metal pipe with the SMD piping exposed below slit in membrane material.

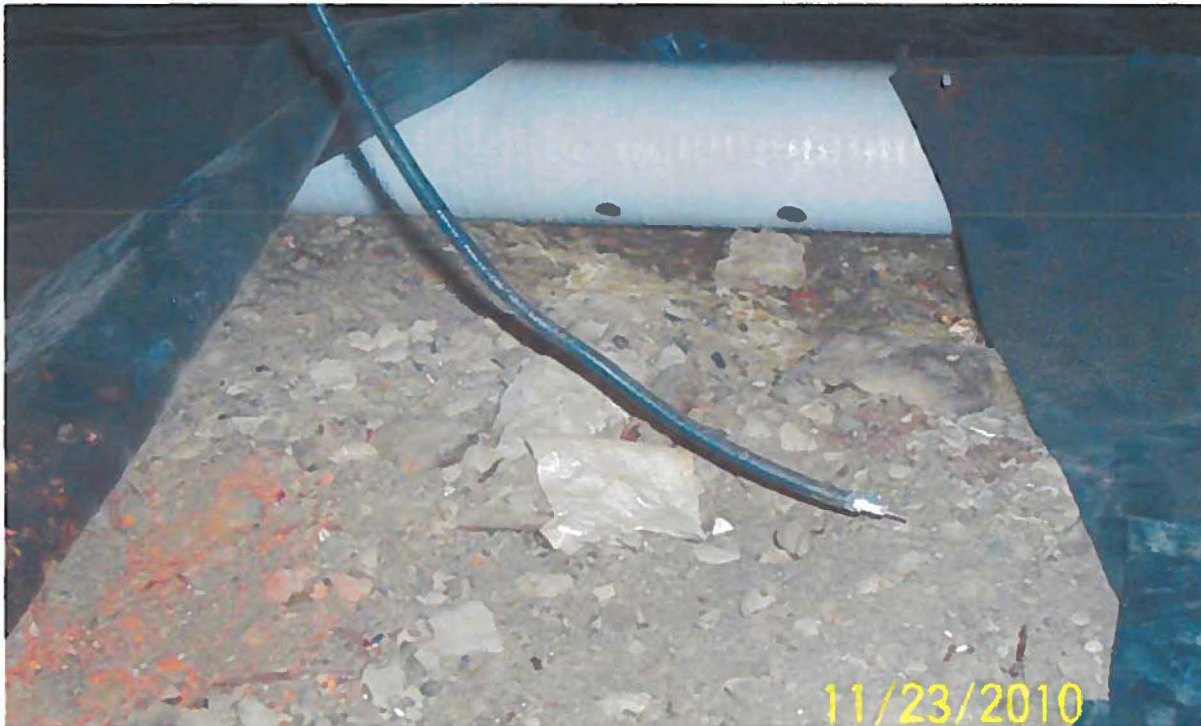
Photograph 4: North Duplex – Exposed SMD piping showing holes on bottom of piping.

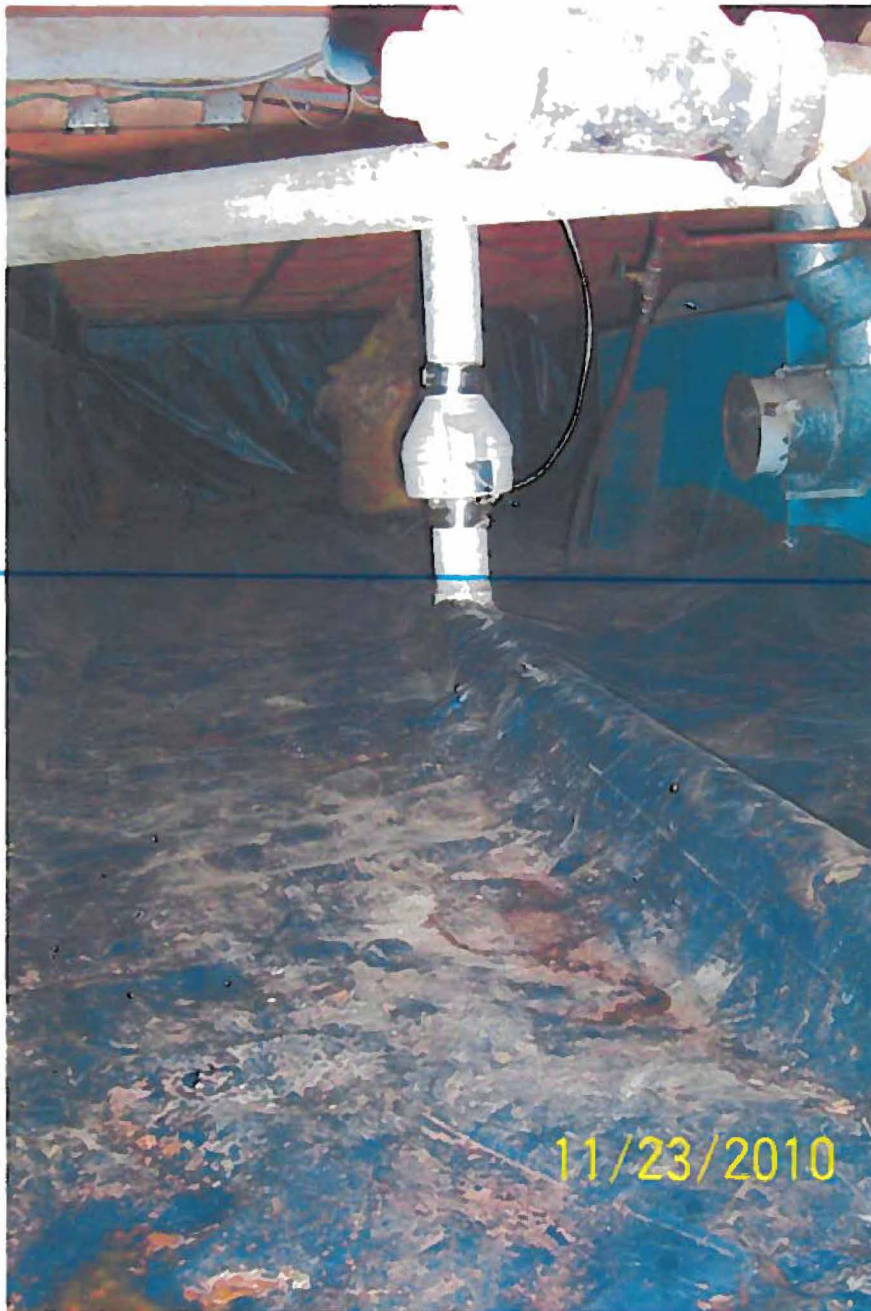
- South Duplex – Photographs 5 through 7 in Attachment 2 show that the South Duplex crawl space membrane seal appears to be complete and well sealed with no visible penetrations. Due to the restricted access to the crawl space we were unable to verify that the SMD pump was operating at the time of inspection. The exhaust pipe exiting the side of the duplex was also checked but no discernable air flow could be observed.

Photograph 5: South Duplex SMD system. No visible holes in membrane liner at this location.

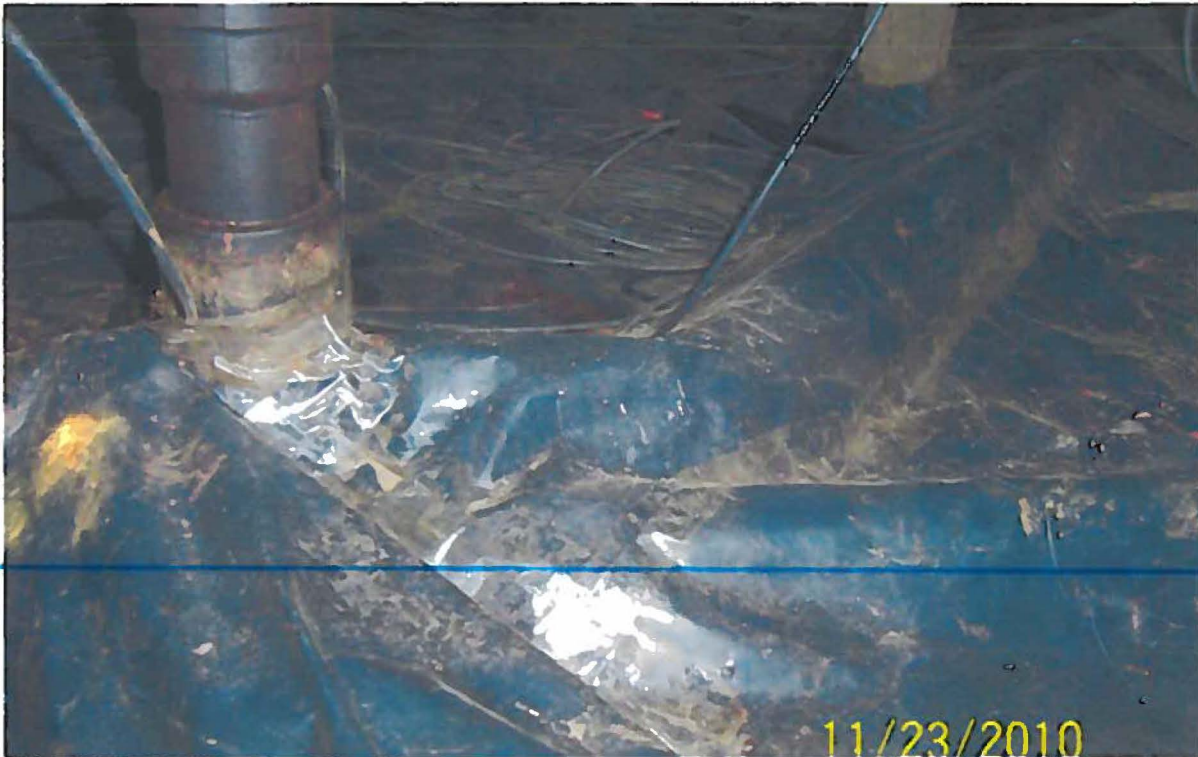
Photograph 6: South Duplex – Notice membrane liner is taped to vertical penetration for better seal.

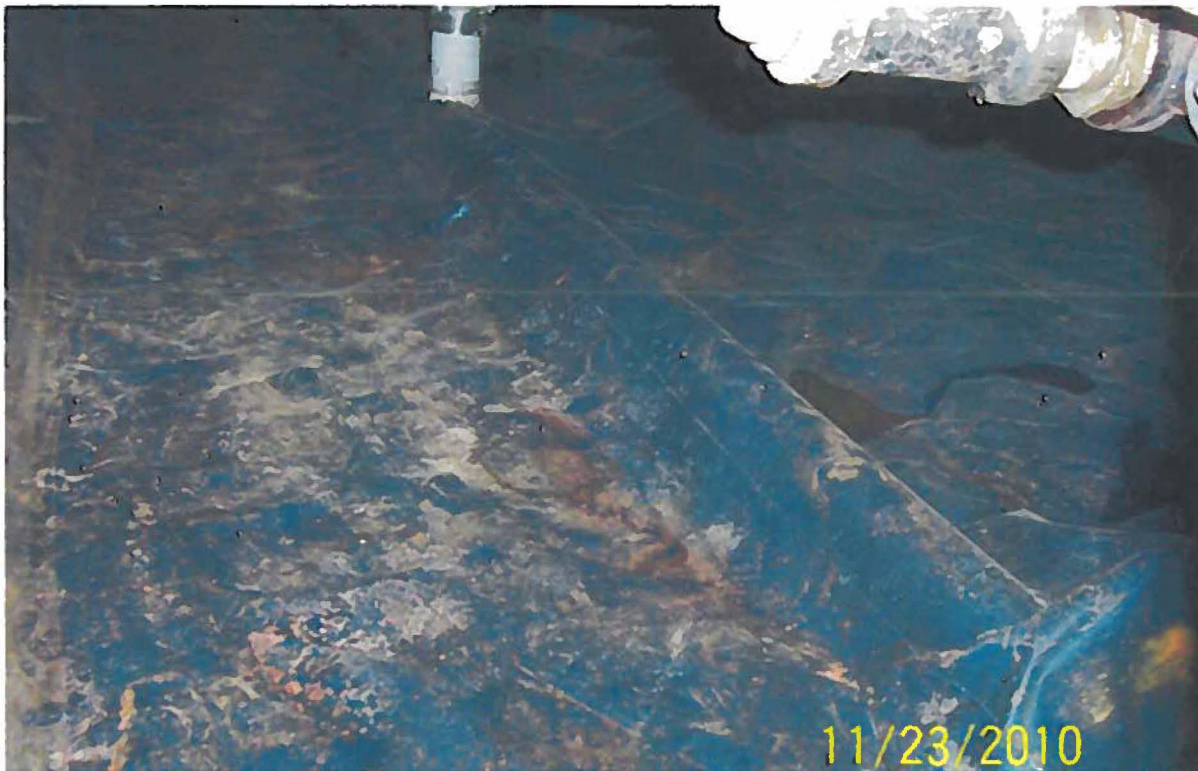
Photograph 7: South Duplex – Notice horizontal piping under membrane liner attached to vertical piping and SMD radon air pump.

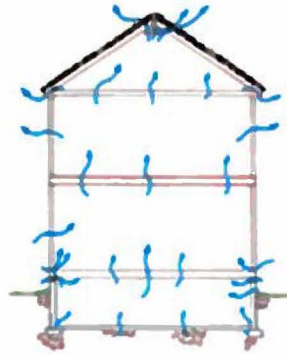
Picture 8: House Stack Effect - The "stack effect" is when warm air moves upwards in a house. This happens in summer and winter. Warm air rises - because it's lighter than cold air. So when it rises, what happens? It escapes out of the upper levels of our homes. But we can't create a vacuum in our homes, so when air escapes, new air has to come in to replace the air that escaped. Where does the new air enter the house? ...at the lower levels, through crawl space vents and up from the earth. The stack effect actually causes your house to suck on the ground. Reference www.basementsystems.com
